RF50-FR

Rear Fixed 50mm Fire Rated Rainscreen System

CLASSIFICATION REPORT EUI-20-000374- Revision 1

FIRE PERFORMANCE CLASSIFICATION IN ACCORDANCE WITH BR 135 (3rd edition): 2013, as tested according to BS 8414-2:2020.

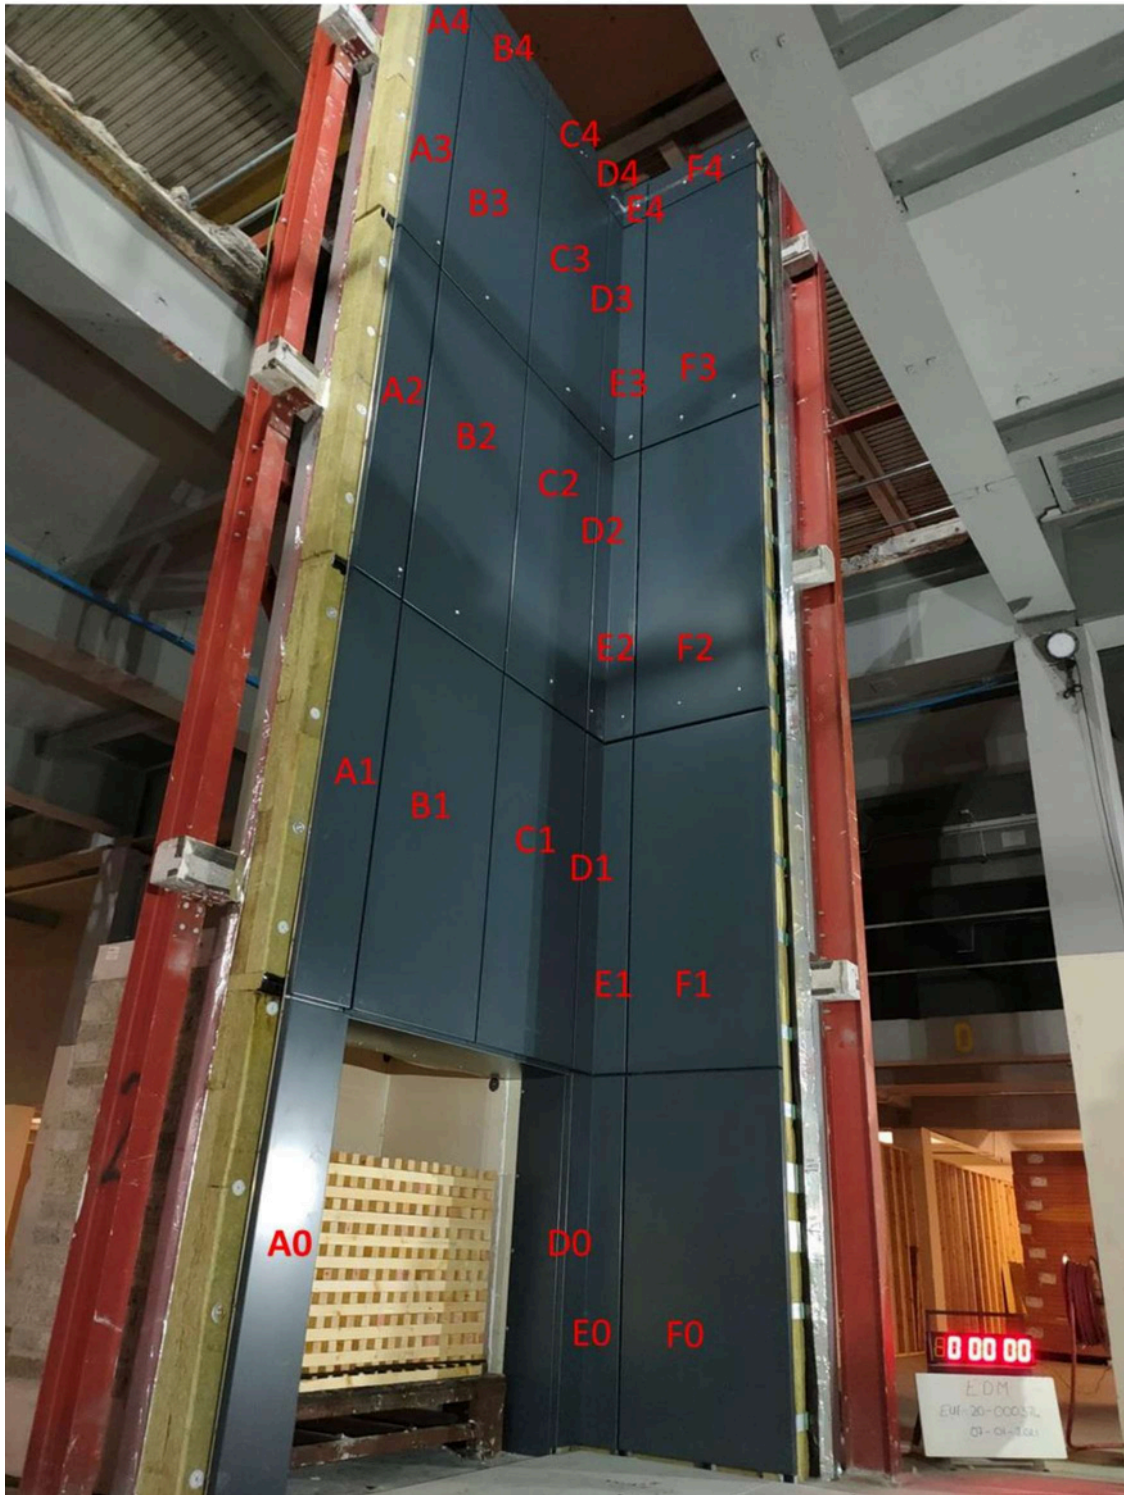
Figure 27. Panel numbering added by the testing laboratory.

Panels A0, A1, A2, A3, A4, B3, B4, C3, C4, D0, D1, D2, D3, D4, E0, E1, E2, E3, E4, F0, F1, F2, F3 and F4 remain intact and in-place after testing.

Panels B1 and C1 melted and collapse by about 60% on the left-hand and right-hand side, respectively. Panels B2, C2 melted and collapse by about 5% on the bottom middle corner.

Panels A2, D2, E2, F2, A3, B3, C3, D3, F3, E3, A4, B4, C4, D4, E4 and F4: no delamination was observed after the test. Minor discoloration and smoke staining were noted on the panels E2, F2, B3 and C3.

Panels A0, A1, D0, D1, E0, E1: Some discolorations/delamination were noticed on the side exposed to the opening of the combustion chamber.

Panels F0 and F1: These 2 panels show some minor deformations. Also, discoloration and delamination were noticed on the panels, approximately 30% of the panels.

Panels B1 and C1: Melted by about 60% on the left-hand and right-hand side, respectively. The rest was deformed and discoloured/delaminated.

Panels B2, C2: Most of the panels remain in place after testing. Approximately 5% of the panels melted on the bottom middle corner. 50% of the panels were discoloured and out of this 50%, 20% was delaminated. This panels also show some deformation.

Panels A2, D2, E2, F2, A3, B3, C3, D3, F3, E3, A4, B4, C4, D4, E4 and F4: Intact and in-place after testing. Minor discoloration and smoke staining were noted on the panels E2, F2, B3 and C3.

Panels A0, A1, D0, D1, E0, E1: In place after testing. Some discolorations/delamination were noticed on the side exposed to the opening of the combustion chamber.

Panels F0 and F1: remain in place after testing. These 2 panels show some minor deformations. Also, discoloration and delamination were noticed on the panels, approximately 30% of the panels.

Panels B2 and C2: Melted by about 60% on the left-hand and right-hand side, respectively. The rest was deformed and discoloured/delaminated.

Panels B3, C3: Most of the panels remain in place after testing. Approximately 5% of the panels melted on the bottom middle corner. 50% of the panels were discoloured and out of this 50%, 20% was delaminated. This panels also show some deformation.

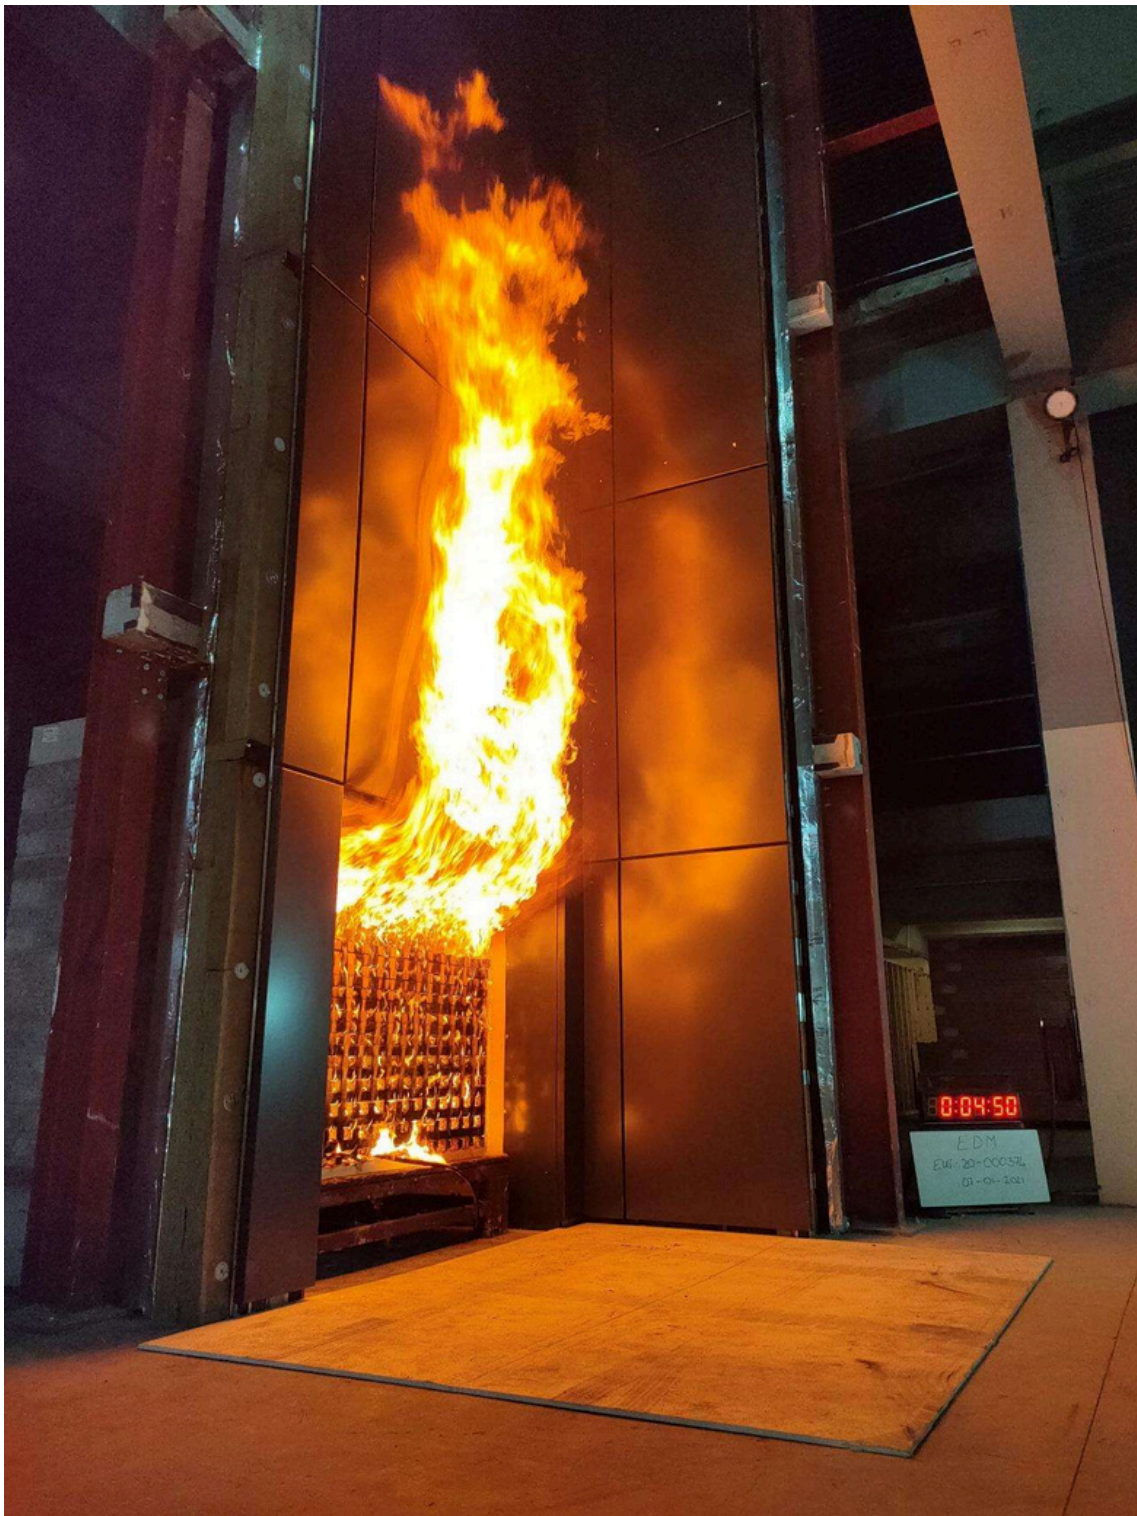
The system collapse started at 4 min 20 s after ignition

Figure 28. Cladding system during the fire test (4 min 50 sec after ignition of the crib).

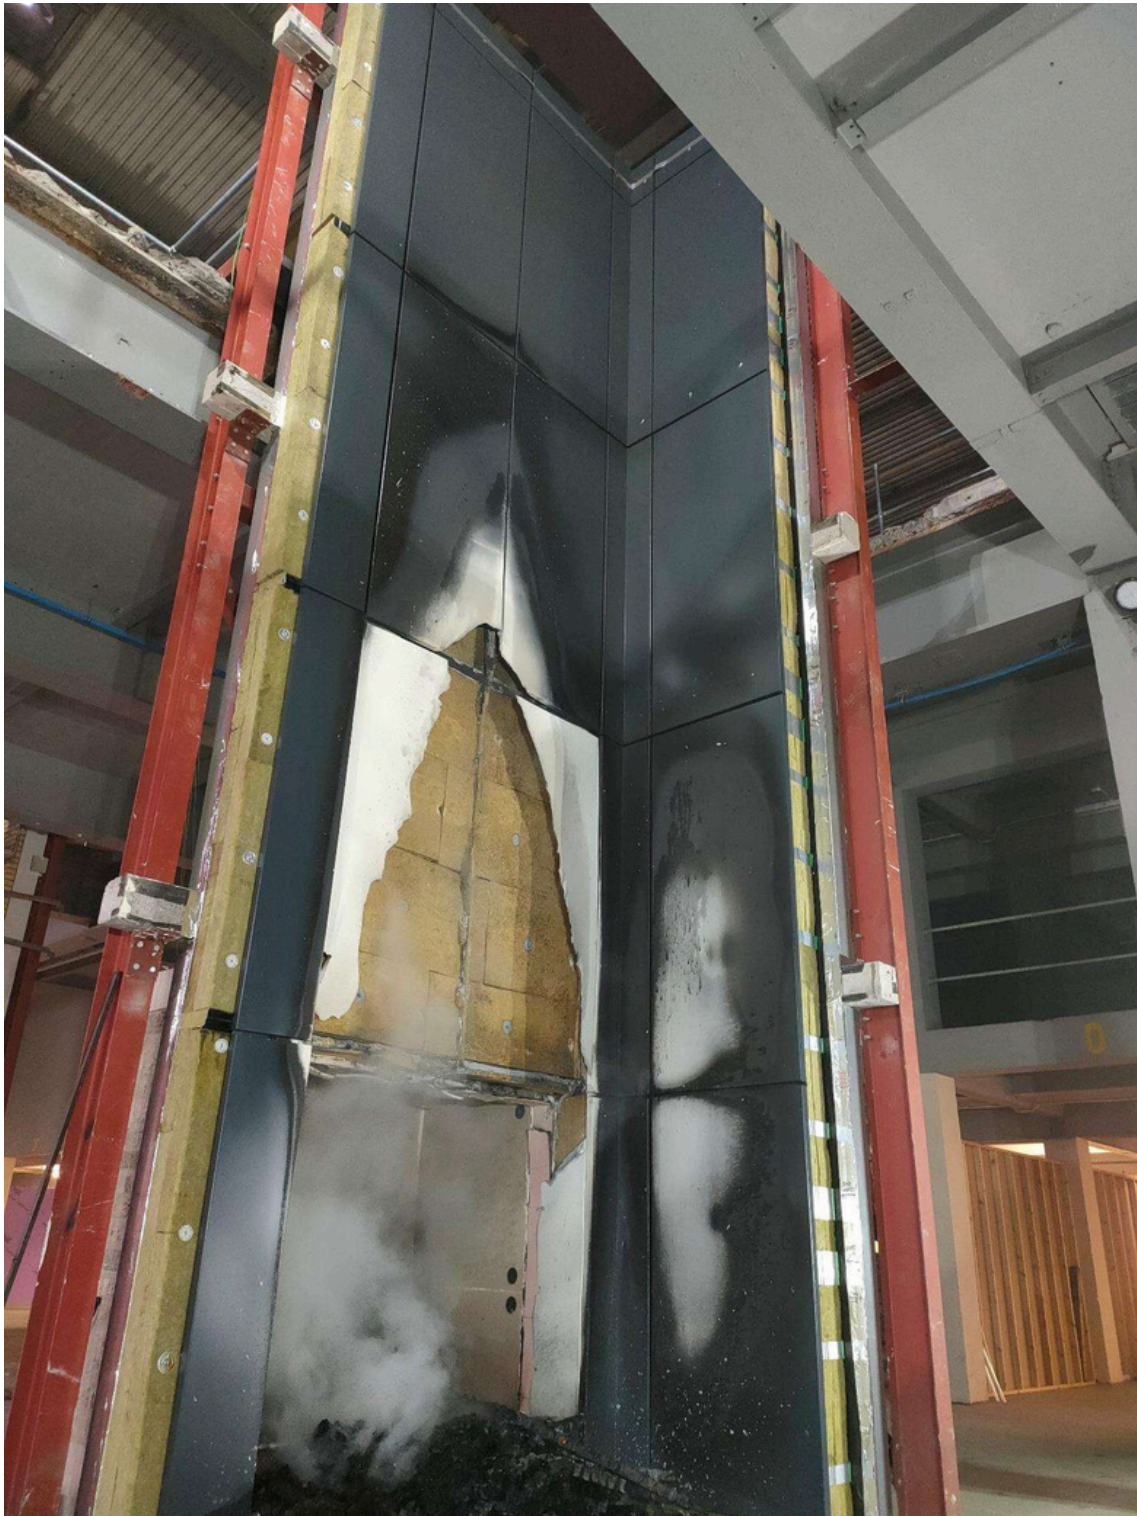
Figure 30. Cladding system just after the fire test (front view).

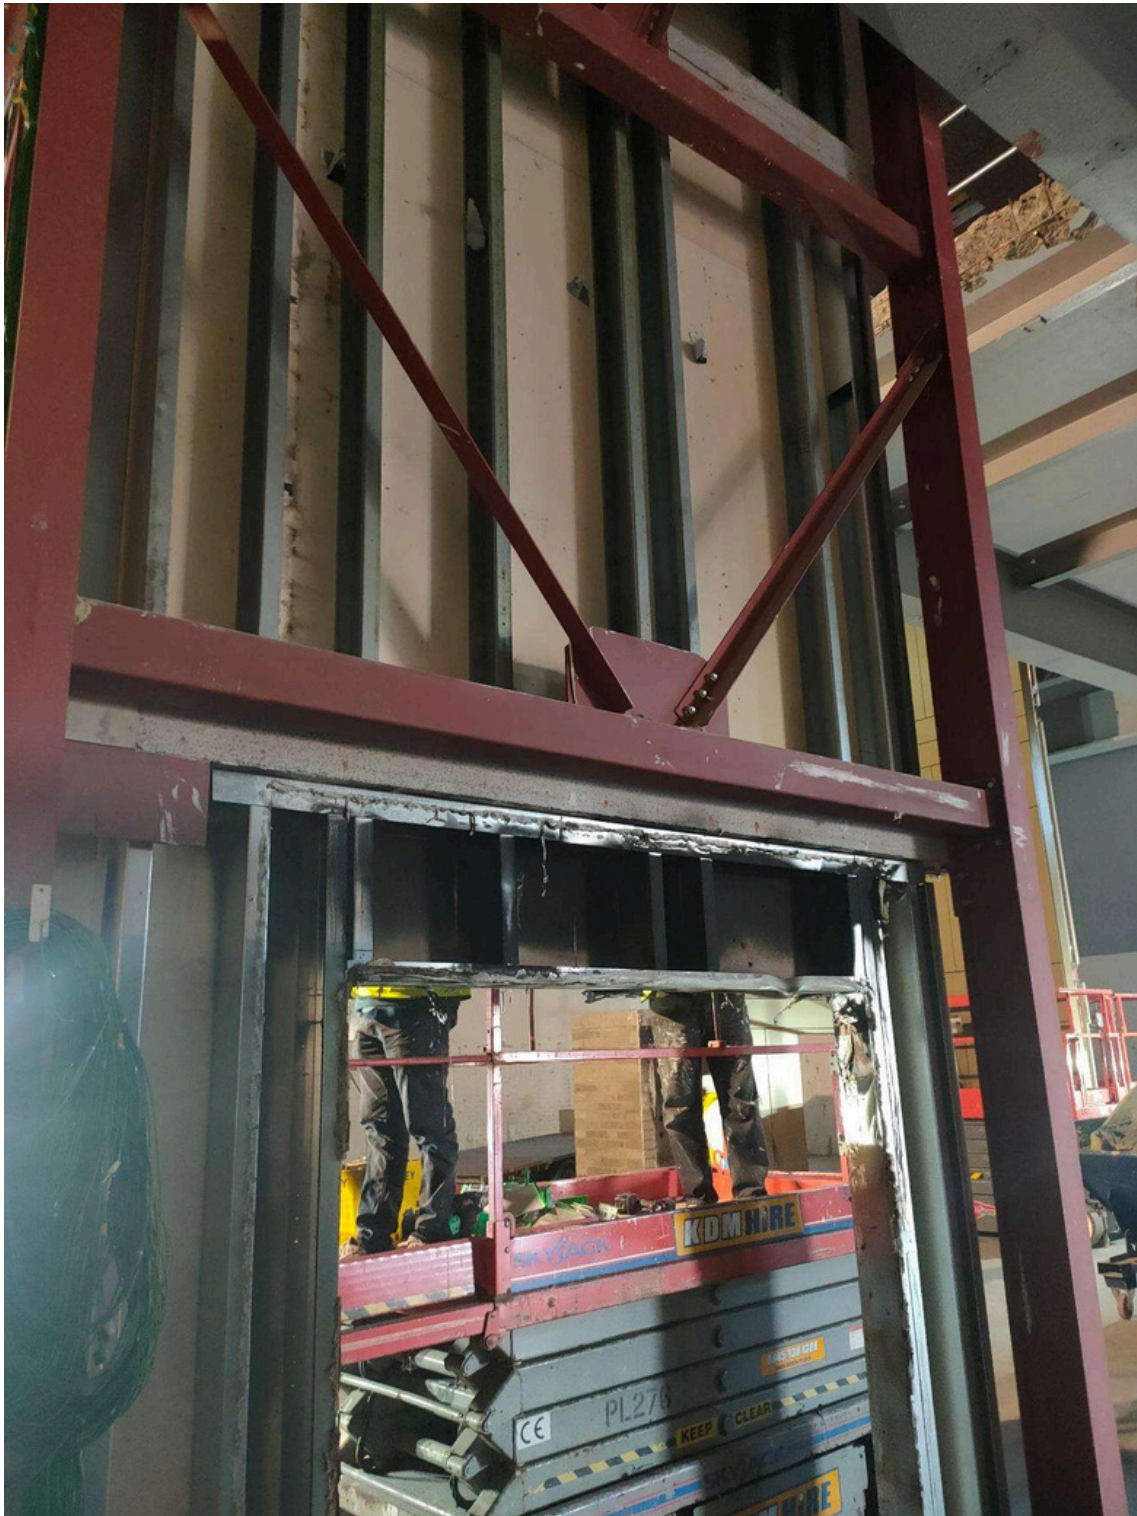
Figure 31. Cladding system after the test (back side view)

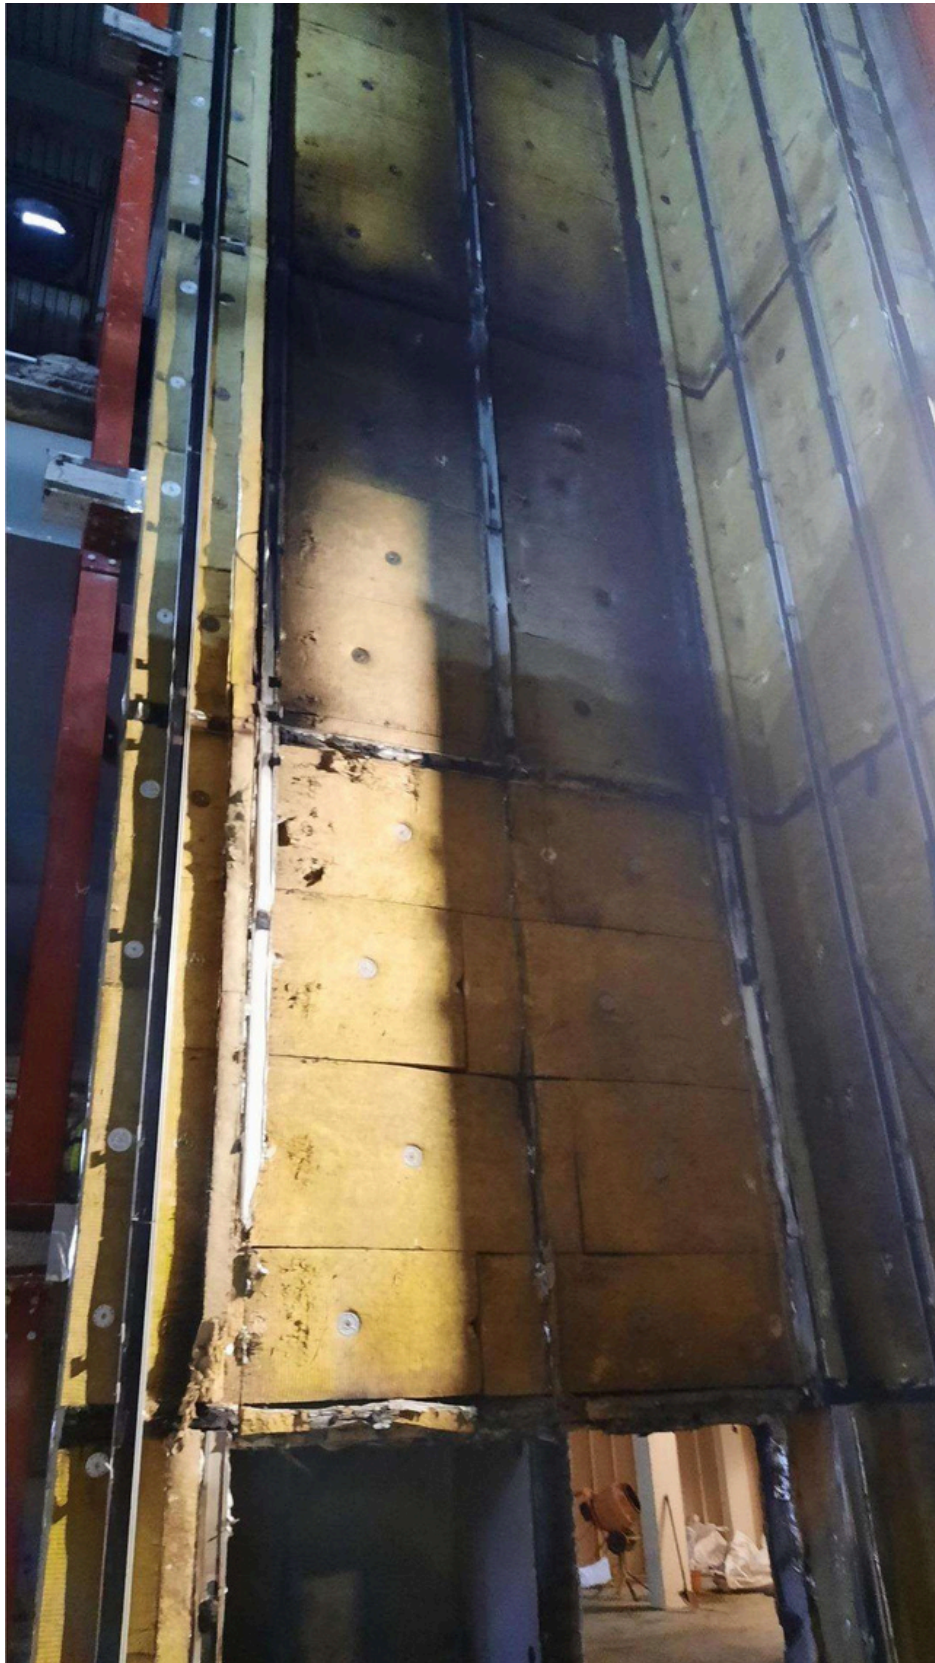
The bottom one, located just above the opening was partly detached during the test, about 500mm. The intumescent strip was detached during the test and only the core material was left on.

The 2nd horizontal cavity barrier located at 4 377.5 mm above the floor level was fully activated during the test for the main face and partially activated for the wing face. There was also detachment of the intumescent material in line with the opening of the combustion chamber in-between the vertical cavity barriers.

The 3rd horizontal cavity barrier located at 6 877.5 mm above the floor level was activated during the test and it remained in full on the main face. On the wing face the cavity barrier the weather-resistant polymer film melted but the cavity barrier was not activated.

Finally, the top cavity barrier located at 9 377.5 mm above the floor level was partially activated on the main face during the test, but it remained in full on both faces. On the main face, it was activated at about 1/2 of its full width with the non-activated part being close to the left-hand side edge of the specimen. On the wing face, the weather-resistant polymer film melted but the cavity barrier was not activated.

The vertical barriers located on either side of the opening were in-place after testing having suffered some discoloration starting at approx. 1500 mm to the 2nd horizontal cavity barrier. Some smoke staining was noticed on the full length of the vertical cavity barriers.

All Rockwool Rainscreen Duo Slab (ROCKWOOL) remained intact and in-place after testing, with heat damage and discoloration visible on the main face of the specimen.

On the main face, above the opening and up to about 4 377.5 mm (up to the 2nd cavity barrier) white discoloration covering about 3.8 m² surface area between the 2 vertical cavity barriers. On the same area, some of the insulation slabs were of rough texture with visible signs of damage. Above the 2nd cavity barrier and up to the 3rd one, insulation slab suffered some white discoloration, approximately 2 m² and some black stain discoloration, approximately 2 m². Finally, from the 3rd cavity barrier to the top of the specimen, insulation slabs suffered black discoloration covering about 1.6 m². Above that the insulation remains intact.

Figure 32. Damage investigation – Insulation and fire cavity barrier after the test.

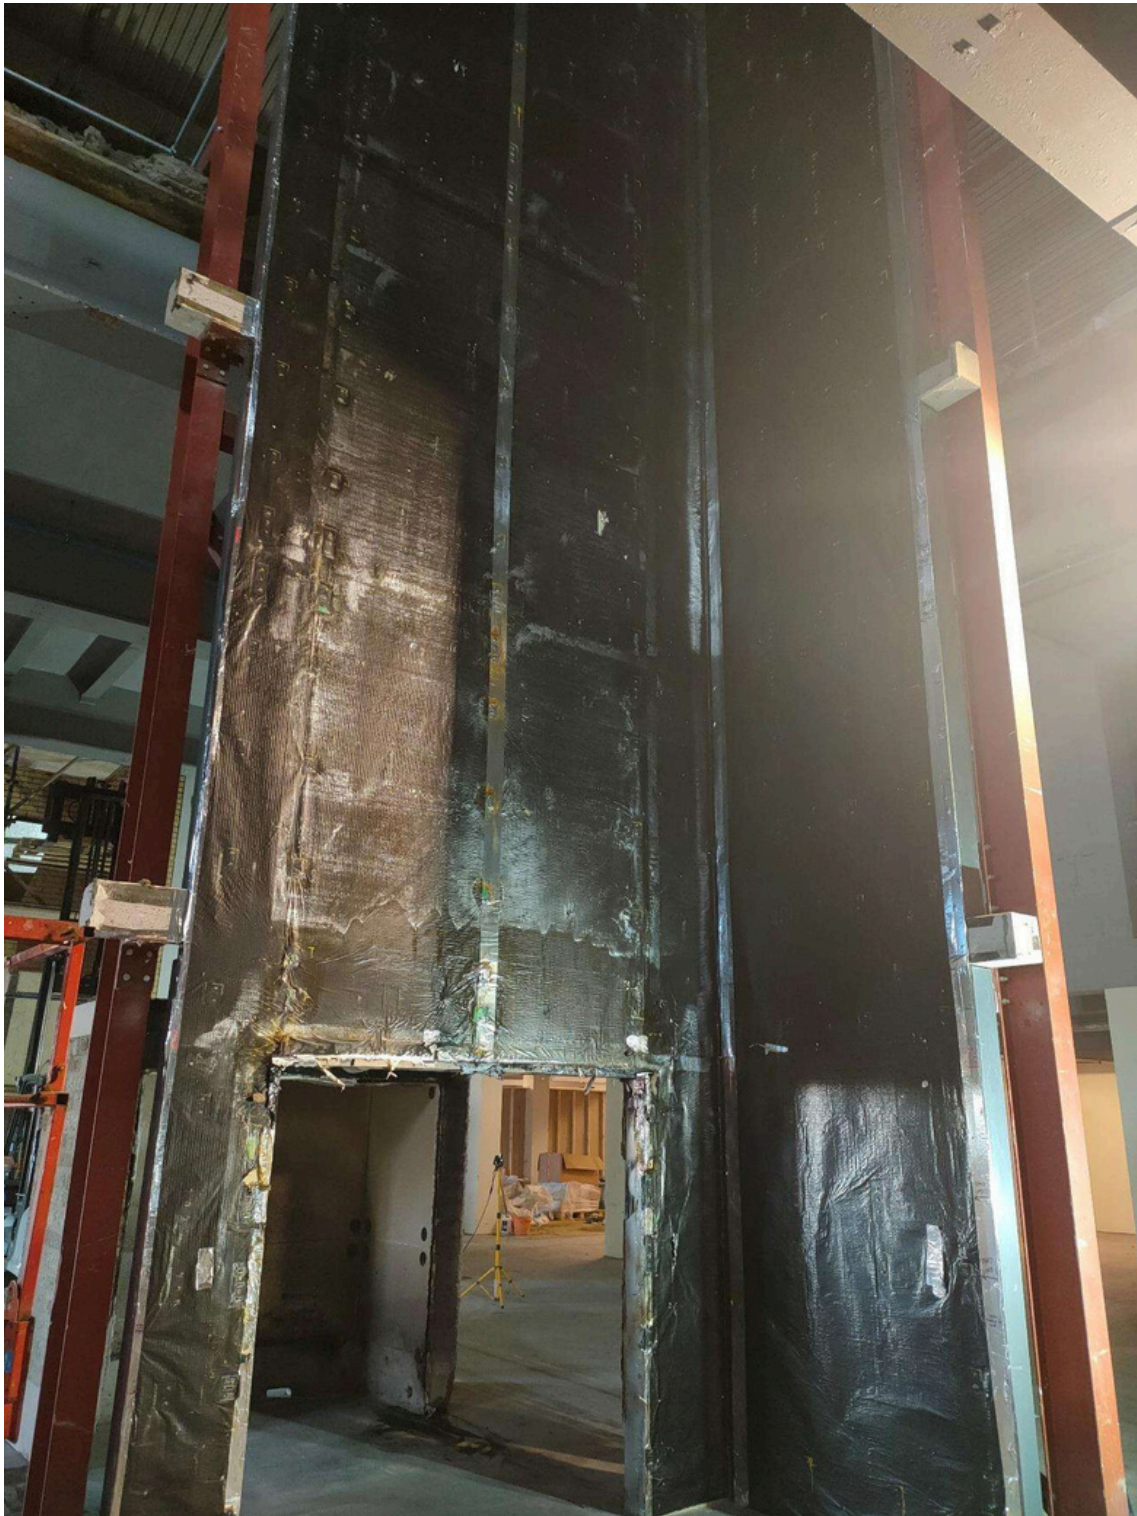
The Fire membrane of the facade system was intact and in-place after the test. We could only notice some discoloration around the combustion chamber opening.

Figure 33. Damage investigation – Air/Vapour membrane after the test.
